**Flood Control Project Maintenance
Levee Inspections**
LMA District Cover Sheet
Spring 2011 Levee Inspection Results

Reclamation District No. 2092 Dos Rios

Levee Inspection Report By Mile - Spring 2011

Waterway							Bank	Unit Miles	Inspection Start/End	Inspector
Unit No. 01 San Joaquin River							Right	3.76	06/02/2011 06/02/2011	Pavel Kazi
LMR No.	Levee Mile		Category	Item	Location	Rating	Action/Comment	GPS Latitude/Longitude		Issue No.
	Start	End						Start	End	Photo
1	0.16	0.16	Earthen Levee	Animal Control	LS	A	No rodents visible, but rodent burrows visible; need to backfill and compact or grout burrows.	37.602125 ° -121.160930 °	37.602125 ° -121.160930 °	31 Y
2	0.16	0.16	Earthen Levee	Animal Control	LS	C	Exterminate rodents and backfill and compact or grout burrows.	37.602125 ° -121.160928 °	37.602125 ° -121.160928 °	2
3	0.19	0.19	Interior Drainage & Piping Systems	Flap Gates	WS	C	Inspector Comments: Flap gate propped open, screw gate appears operational.	37.601999 ° -121.161290 °	37.601999 ° -121.161290 °	966
4	0.19	0.19	Interior Drainage & Piping Systems	Flap Gates	WS	A	Inspector Comments: The flap gate has been replaced recently by the LMA.	37.601999 ° -121.161290 °	37.

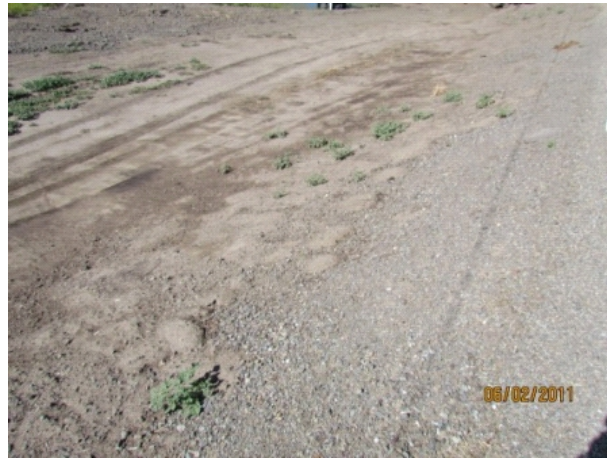
Levee Mile Report Line	1
Start Levee Mile	0.16
End Levee Mile	0.16
Location	Land Side
Category	Earthen Levee
Item	Animal Control
<p>The rodent holes have been compacted to new soil. The picture was taken from the crown looking upstream.</p>	
pkazi_s_20110602_695.jpg

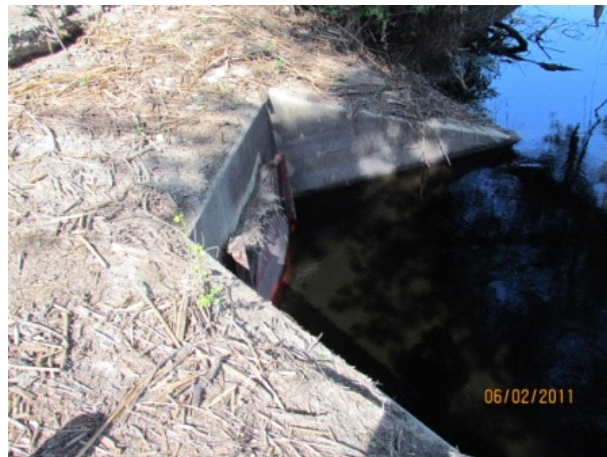
Levee Mile Report Line	4
Start Levee Mile	0.19
End Levee Mile	0.19
Location	Water Side
Category	Interior Drainage & Piping Systems
Item	Flap Gates
<p>The flap gate seems to be fully operational and shows no damage since the gate is new. The picture was taken from the waterside of the levee looking upstream.</p>	
pkazi_s_20110602_696.jpg

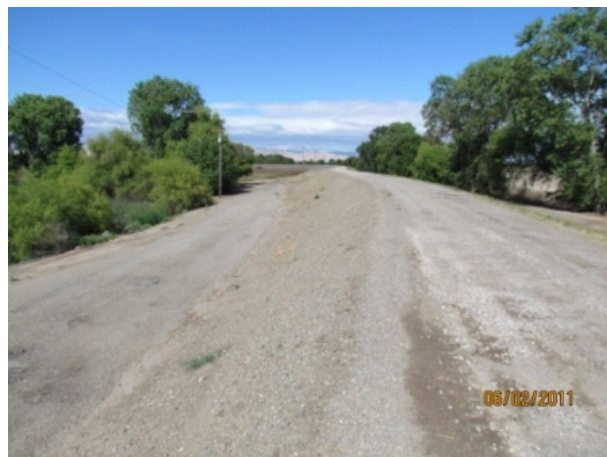
Levee Mile Report Line	6
Start Levee Mile	0.21
End Levee Mile	0.24
Location	Land Side
Category	Earthen Levee
Item	Vegetation
<p>Vegetation complies within the standards on the landside slope of the levee. The picture was taken from the crown looking upstream.</p>	
pkazi_s_20110602_697.jpg

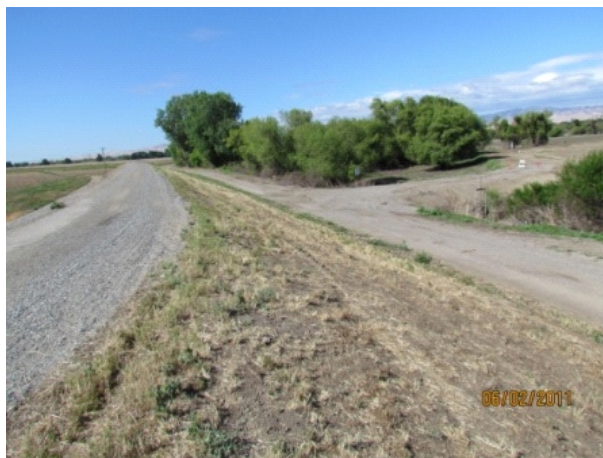
Levee Mile Report Line	8
Start Levee Mile	0.48
End Levee Mile	1.79
Location	Water Side
Category	Earthen Levee
Item	Vegetation

Vegetation complies with the standards at the waterside slope of the levee. The picture was taken from the crown looking upstream.

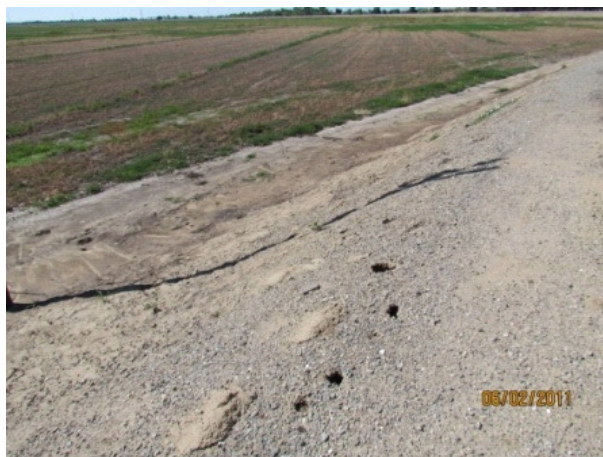
Levee Mile Report Line	10
Start Levee Mile	0.62
End Levee Mile	0.62
Location	Land Side
Category	Earthen Levee
Item	Animal Control

Rodent holes were found on the landside of the levee. The picture was taken from the crown looking upstream.

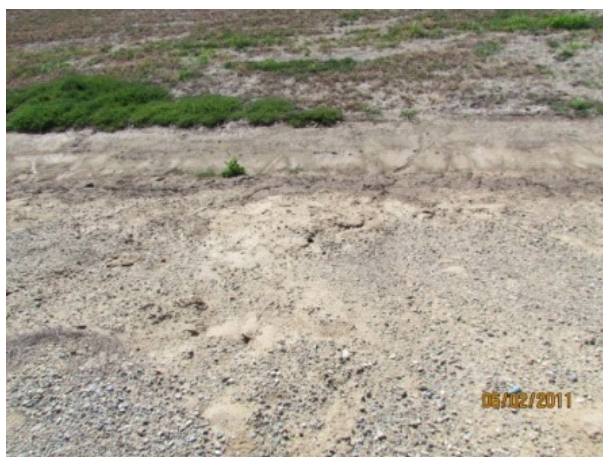
Levee Mile Report Line	11
Start Levee Mile	0.63
End Levee Mile	0.63
Location	Land Side
Category	Earthen Levee
Item	Animal Control

Rodent holes were found on the landside of the levee. The picture was taken from the crown looking towards the landside toe of the levee.

11	0.63	0.63	Earthen Levee	Animal Control	LS	M	No rodents visible, but rodent burrows visible; need to backfill and compact or grout burrows.	37.598848 ° -121.167379 °	37.598848 ° -121.167379 °	20 Y
12	0.63	2.00	Earthen Levee	Seepage / Sandboils	LS	U	Inspector Comments: Seepage occurred in the area.	37.598848 ° -121.167378 °	37.584319 ° -121.159483 °	21 Y
13	0.77	1.33	Earthen Levee	Encroachments	LS	PO	Agricultural Ditch	37.597291 ° -121.168496 °	37.590568 ° -121.164028 °	968 Y
14	0.86	0.86	Earthen Levee	Erosion / Bank Caving	LS	M	Schedule repair of erosion site prior to the next inspection.	37.595986 ° -121.168249 °	37.595986 ° -121.168249 °	22 Y
15	1.31	1.31	Earthen Levee	Slope Stability	LS	M	Repair slope instability.	37.590667 ° -121.164220 °	37.590667 ° -121.164220 °	23 Y
16	1.34	1.57	Earthen Levee	Encroachments	LS	PO	Agricultural Ditch	37.590479 ° -121.163844 °	37.587758 ° -121.162349 °	7
17	1.47	1.47	Earthen Levee	Animal Control	LS	M	No rodents visible, but rodent burrows visible; need to backfill and compact or grout burrows.	37.589061 ° -121.162168 °	37.589061 ° -121.162168 °	24

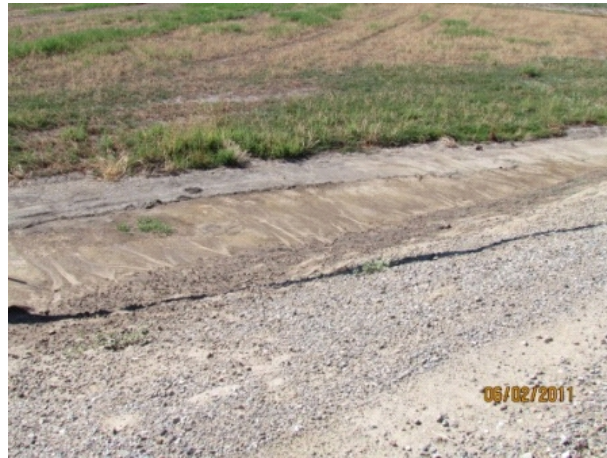
Levee Mile Report Line	12
Start Levee Mile	0.63
End Levee Mile	2.00
Location	Land Side
Category	Earthen Levee
Item	Seepage / Sandboils

Seepage occurred at the toe of the landside of the levee 2 weeks prior to inspection. The picture was taken from the crown looking upstream.

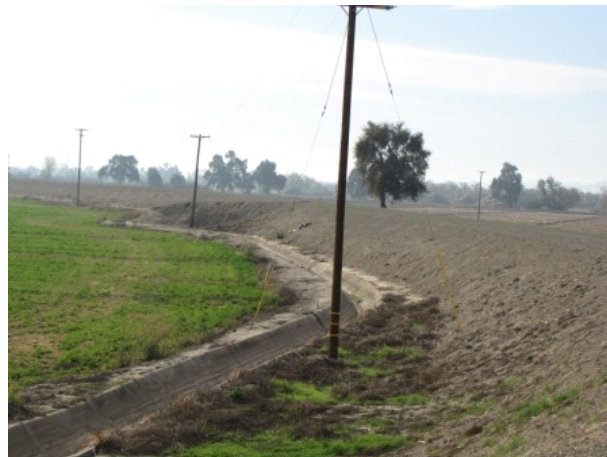
Levee Mile Report Line	13
Start Levee Mile	0.77
End Levee Mile	1.33
Location	Land Side
Category	Earthen Levee
Item	Encroachments

View of agricultural ditch at the landward toe looking upstream.

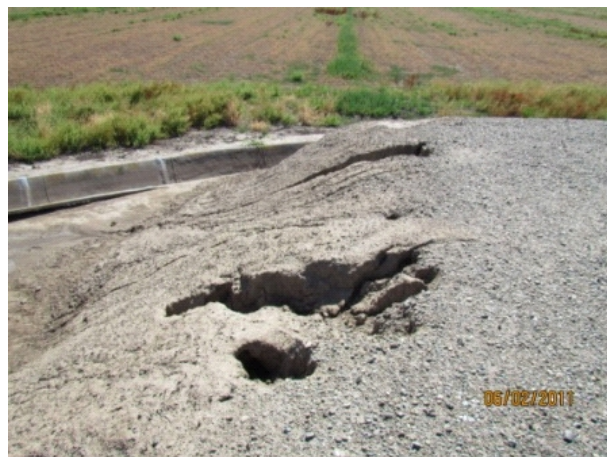
Levee Mile Report Line	14
Start Levee Mile	0.86
End Levee Mile	0.86
Location	Land Side
Category	Earthen Levee
Item	Erosion / Bank Caving

Erosion occurred due to rain runoff. The picture was taken from the crown looking toward the landside of the levee.

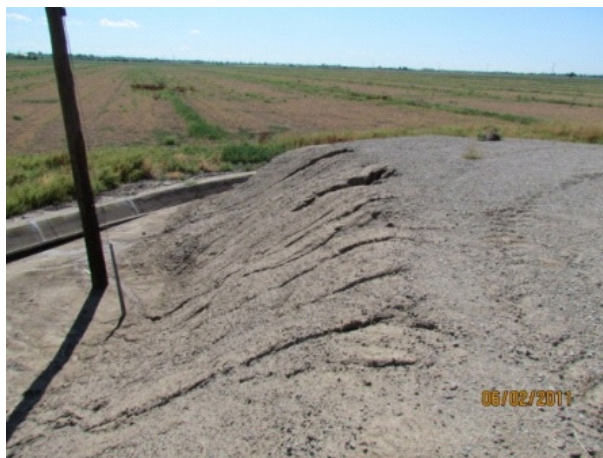
Levee Mile Report Line	14
Start Levee Mile	0.86
End Levee Mile	0.86
Location	Land Side
Category	Earthen Levee
Item	Erosion / Bank Caving

Slope instability due to erosion occurred on the landside of the levee. The picture was taken from the crown looking upstream.

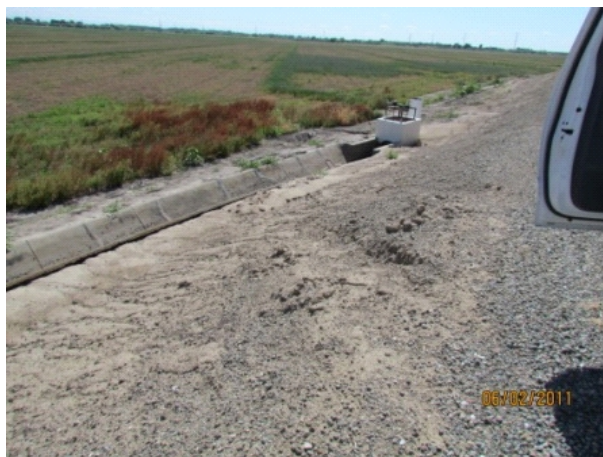
Levee Mile Report Line	15
Start Levee Mile	1.31
End Levee Mile	1.31
Location	Land Side
Category	Earthen Levee
Item	Slope Stability

Slope instability was found on the landside shoulder of the levee. The picture was taken from the crown looking upstream.

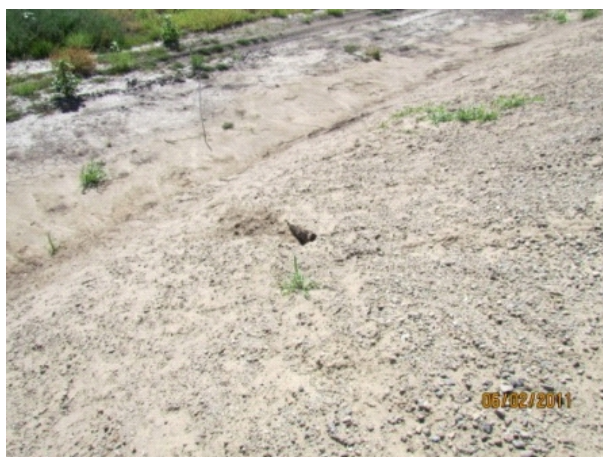
Levee Mile Report Line	18
Start Levee Mile	1.47
End Levee Mile	1.47
Location	Land Side
Category	Earthen Levee
Item	Slope Stability

A rodent hole was found on the landside of the levee. The picture was taken from the crown looking upstream.

18	1.47	1.47	Earthen Levee	Slope Stability	LS	M	Repair slope instability.	37.589061 ° -121.162168 °	37.589061 ° -121.162168 °	25 Y

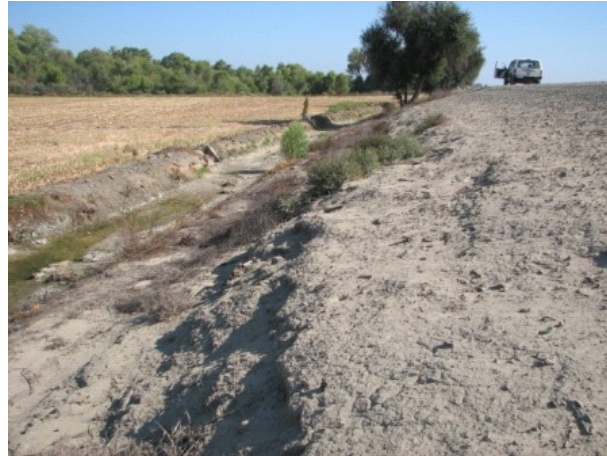
Levee Mile Report Line	19
Start Levee Mile	1.55
End Levee Mile	1.69
Location	Water Side
Category	Supplemental
Item	DWR Erosion Survey

2009: No major change; sloughing at the lower slope that's created a terraced effect; damage could be caused by wave action during an extended flooding; site recommended as local maintenance issue, per CLRO CES Evaluation 2008 Report; previously rated "M" [2009 SiteID:RD2092U1RM84.6]

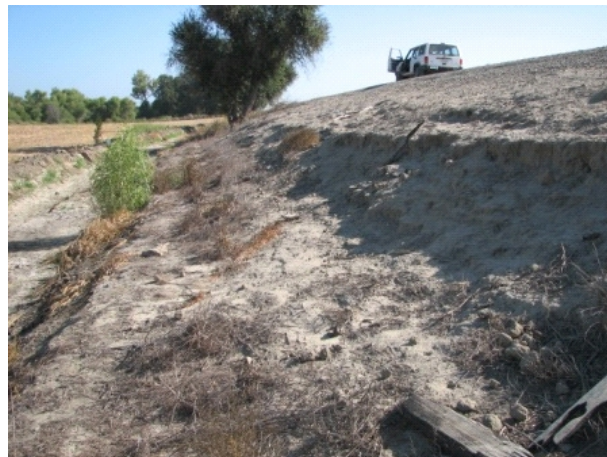
Levee Mile Report Line	19
Start Levee Mile	1.55
End Levee Mile	1.69
Location	Water Side
Category	Supplemental
Item	DWR Erosion Survey

2009: No major change; sloughing at the lower slope that's created a terraced effect; damage could be caused by wave action during an extended flooding; site recommended as local maintenance issue, per CLRO CES Evaluation 2008 Report; previously rated "M" [2009 SiteID:RD2092U1RM84.6]

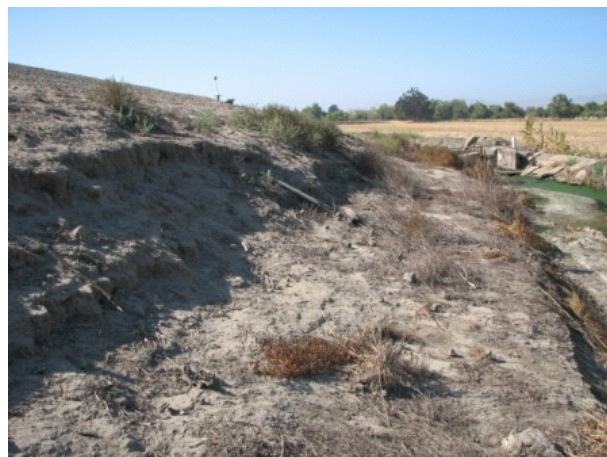
Levee Mile Report Line	19
Start Levee Mile	1.55
End Levee Mile	1.69
Location	Water Side
Category	Supplemental
Item	DWR Erosion Survey

2009: No major change; sloughing at the lower slope that's created a terraced effect; damage could be caused by wave action during an extended flooding; site recommended as local maintenance issue, per CLRO CES Evaluation 2008 Report; previously rated "M" [2009 SiteID:RD2092U1RM84.6]

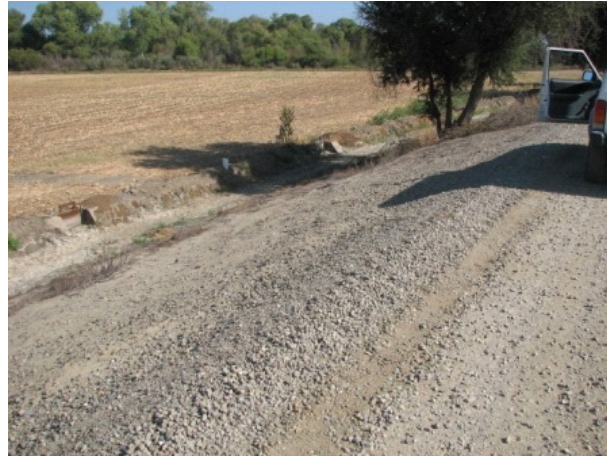
Levee Mile Report Line	19
Start Levee Mile	1.55
End Levee Mile	1.69
Location	Water Side
Category	Supplemental
Item	DWR Erosion Survey

2009: No major change; sloughing at the lower slope that's created a terraced effect; damage could be caused by wave action during an extended flooding; site recommended as local maintenance issue, per CLRO CES Evaluation 2008 Report; previously rated "M" [2009 SiteID:RD2092U1RM84.6]

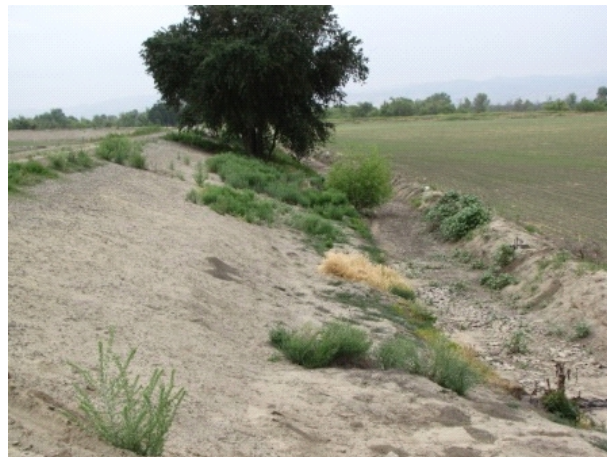
Levee Mile Report Line	20
Start Levee Mile	1.59
End Levee Mile	1.87
Location	Water Side
Category	Earthen Levee
Item	Encroachments

View of an agricultural ditch at the waterward toe of the slope.

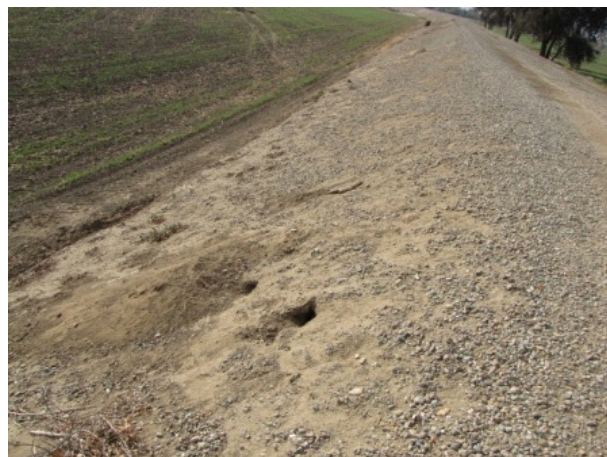
Levee Mile Report Line	21
Start Levee Mile	1.59
End Levee Mile	1.62
Location	Land Side
Category	Earthen Levee
Item	Animal Control

View of rodent holes in landward slope looking upstream.

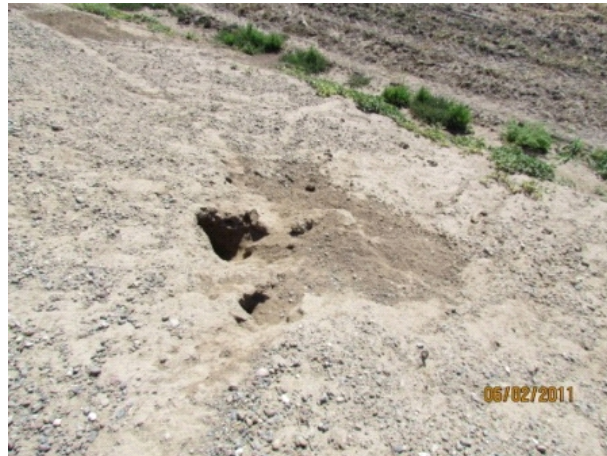
Levee Mile Report Line	21
Start Levee Mile	1.59
End Levee Mile	1.62
Location	Land Side
Category	Earthen Levee
Item	Animal Control

Rodent hole on the landside of the slope seems to be bigger since the last inspection. The picture was taken from the crown looking upstream.

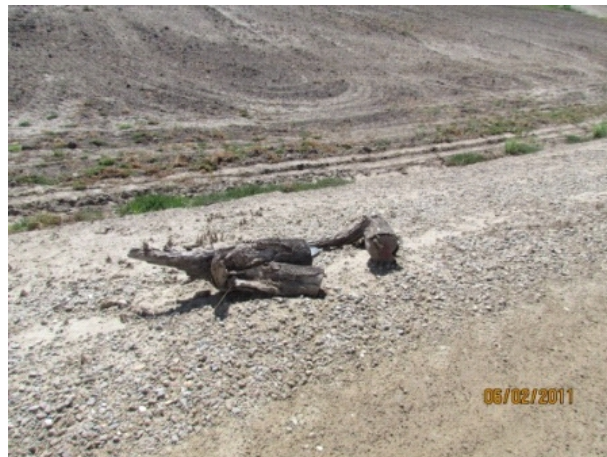
Levee Mile Report Line	22
Start Levee Mile	1.75
End Levee Mile	1.75
Location	Land Side
Category	Earthen Levee
Item	Encroachments

Tree limbs were found on the landside of the levee looking upstream.

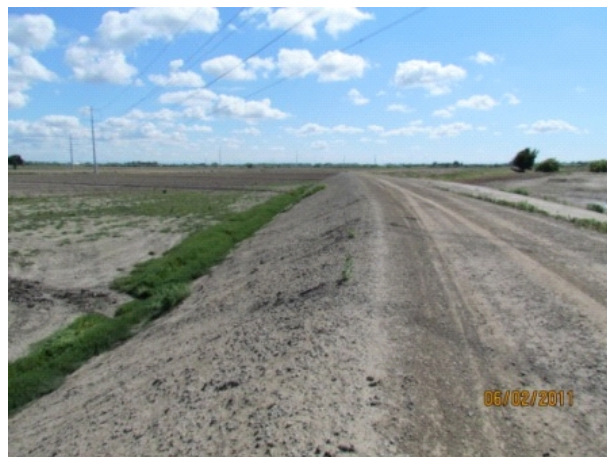
Levee Mile Report Line	24
Start Levee Mile	1.94
End Levee Mile	1.94
Location	Land Side
Category	Earthen Levee
Item	Vegetation

Vegetation complies with the standards on the landside slope of the levee. The picture was taken from the crown looking upstream.

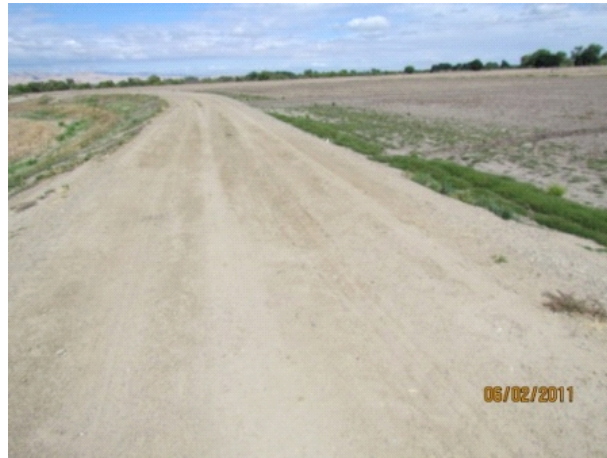
Levee Mile Report Line	26
Start Levee Mile	2.02
End Levee Mile	2.02
Location	Crown
Category	Earthen Levee
Item	Crown Surface / Depressions / Rutting
Crown depression was found due to vehicular traffic. The picture was taken from crown looking downstream.	
pkazi_s_20110602_709.jpg

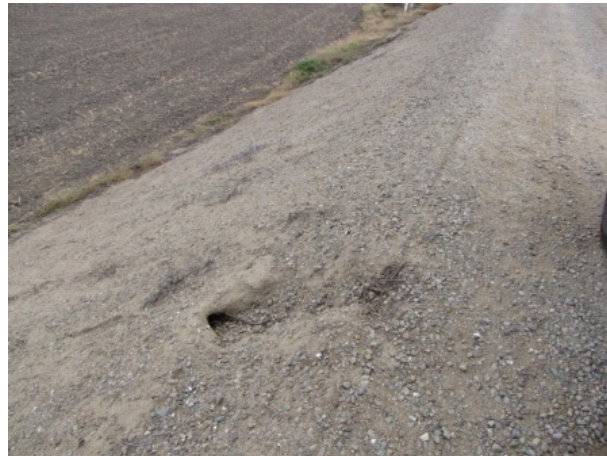
Levee Mile Report Line	28
Start Levee Mile	2.07
End Levee Mile	2.07
Location	Land Side
Category	Earthen Levee
Item	Animal Control
View of rodent holes in the landward shoulder looking upstream.	
pkazi_s_20110328_482.jpg

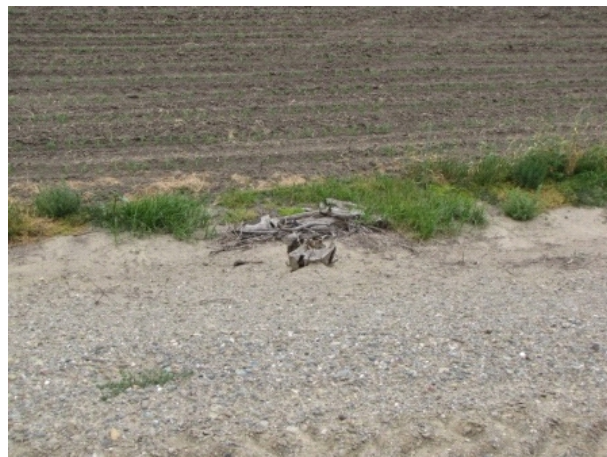
Levee Mile Report Line	30
Start Levee Mile	2.26
End Levee Mile	2.26
Location	Land Side
Category	Earthen Levee
Item	Trim / Thin Trees
View of a stump on the landward slope.	
pkazi_s_20110328_477.jpg

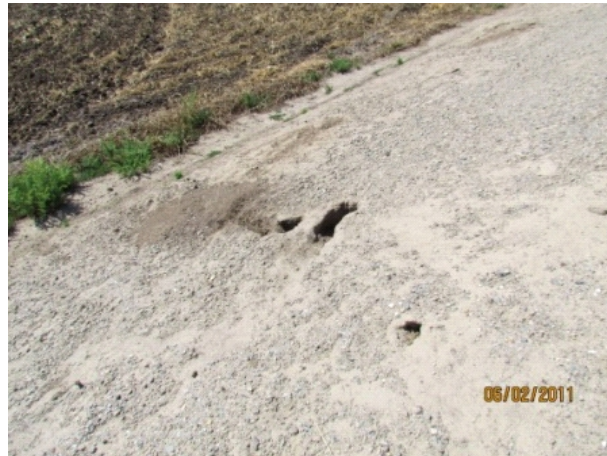
Levee Mile Report Line	31
Start Levee Mile	2.41
End Levee Mile	2.41
Location	Land Side
Category	Earthen Levee
Item	Animal Control

Rodent holes were found on the landside slope of the levee. The picture was taken from the crown looking upstream.

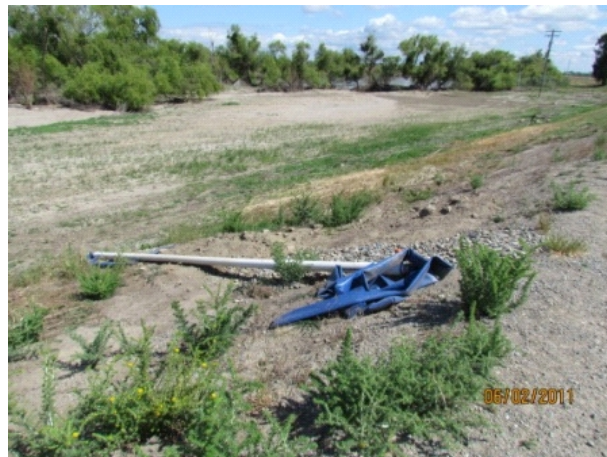
Levee Mile Report Line	33
Start Levee Mile	2.43
End Levee Mile	2.43
Location	Water Side
Category	Earthen Levee
Item	Encroachments

Pipe was left out by the farmer at the waterside of the levee. The picture was taken from the crown looking downstream.

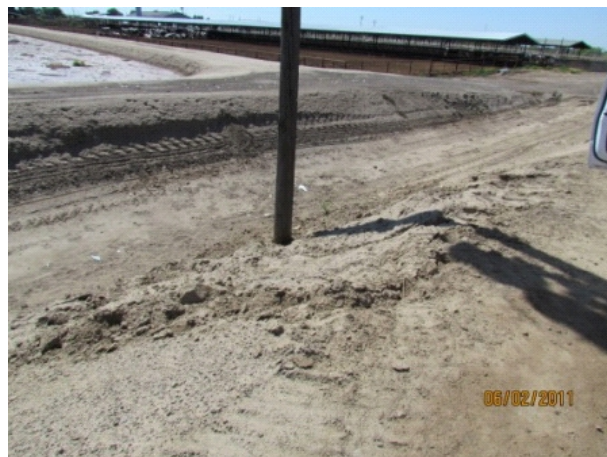
Levee Mile Report Line	35
Start Levee Mile	2.73
End Levee Mile	2.73
Location	Land Side
Category	Earthen Levee
Item	Slope Stability

Slope instability was found on the landside of the levee looking upstream.

LMIR No.	Levee Mile		Category	Item	* Location	** Rating	Action/Comment	GPS Latitude/Longitude		Issue No.
	Start	End						Start	End	Photo
35	2.73	2.73	Earthen Levee	Slope Stability	LS	M	Repair the levee slope damaged by vehicle traffic and prevent access where possible.	37.576336 ° -121.157217 °	37.576336 ° -121.157217 °	30 Y
36	2.81	3.08	Earthen Levee	Vegetation	WS	C	Control annual grass and weeds on the levee slopes and easements.	37.575189 ° -121.156991 °	37.574076 ° -121.152391 °	16
37	2.83	2.83	Earthen Levee	Trim / Thin Trees	WS	A	Thin trees to allow visibility of the ground and room to flood fight.	37.574928 ° -121.156500 °	37.574928 ° -121.156500 °	36 Y
38	2.83	2.83	Earthen Levee	Trim / Thin Trees	WS	C	Trim and thin trees to allow visibility of the ground and room to flood fight.	37.574928 ° -121.156498 °	37.574928 ° -121.156498 °	17
39	2.84	3.09	Earthen Levee	Encroachments	LS	PO	Fences Inspector Comments: Barbed wire fence on landward slope.	37.574973 ° -121.156647 °	37.574001 ° -121.152183 °	972 Y

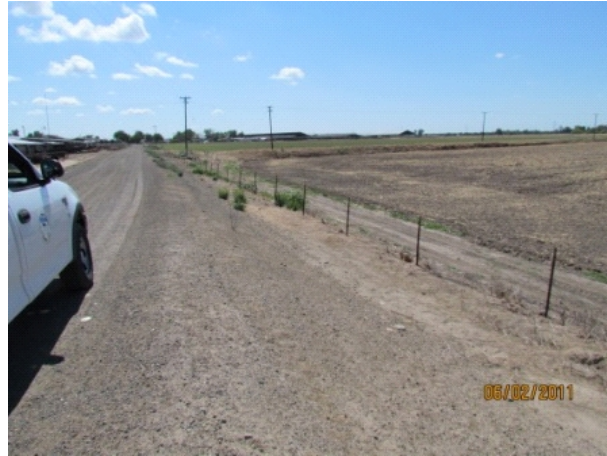
Levee Mile Report Line	37
Start Levee Mile	2.83
End Levee Mile	2.83
Location	Water Side
Category	Earthen Levee
Item	Trim / Thin Trees

No trees were found which obstructed the visibility on the waterside of the levee. The picture was taken from the crown looking upstream.

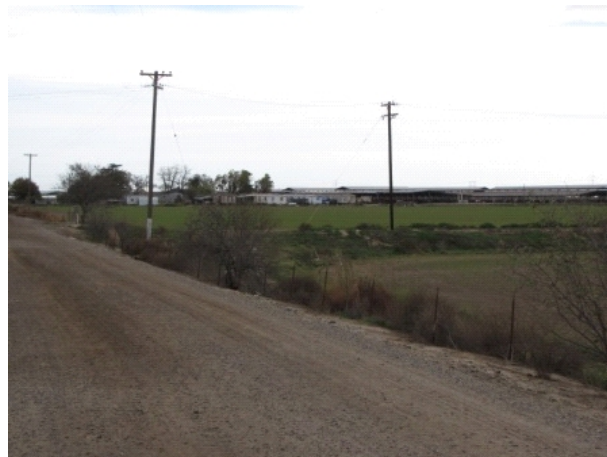
Levee Mile Report Line	39
Start Levee Mile	2.84
End Levee Mile	3.09
Location	Land Side
Category	Earthen Levee
Item	Encroachments

View of barbed wire fence along the waterward slope looking upstream.
